Brinkwood
CH-213
Bryantown vic.
Private

Maryland Inventory of Historic Properties Form

Inventory No. CH-213

historic Brinkwood

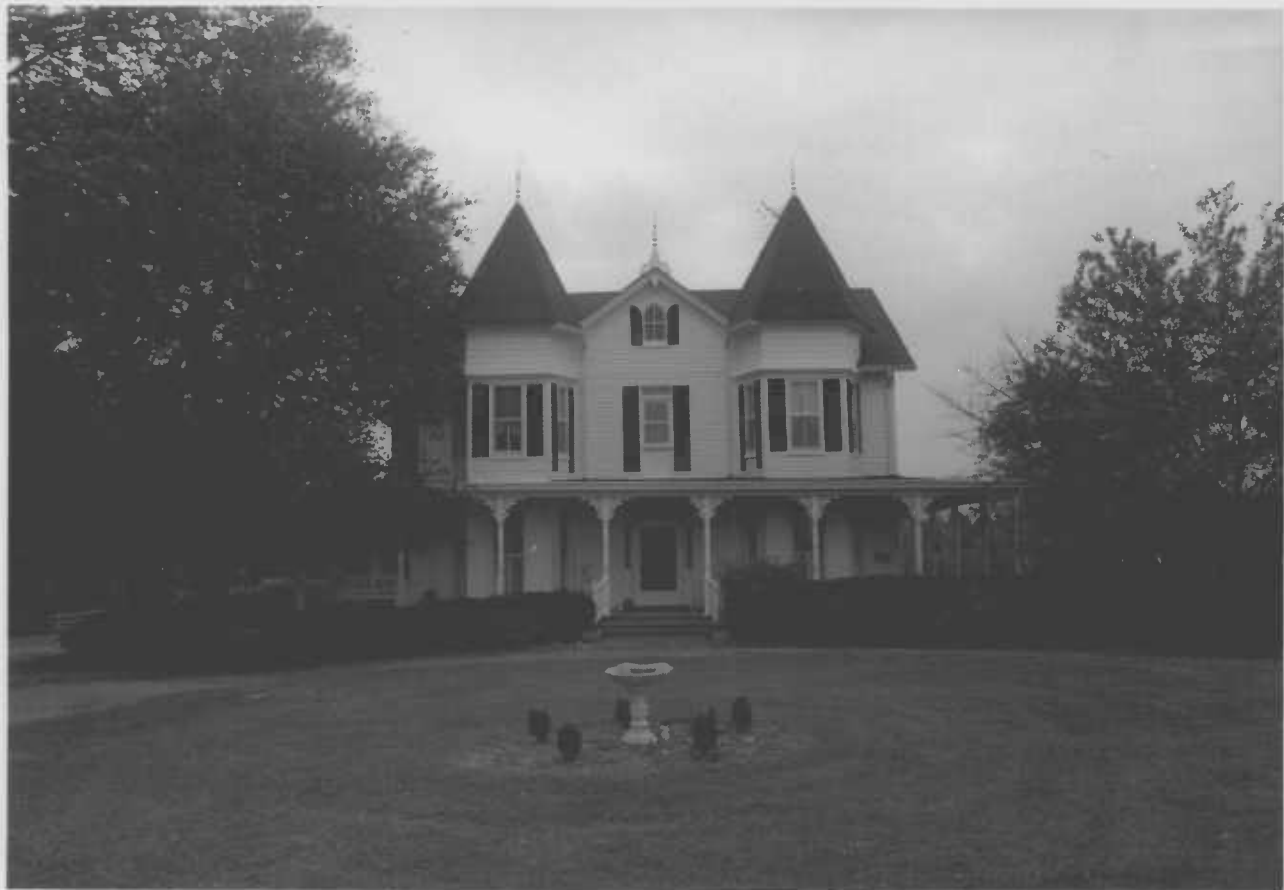
1 OF 18

LOOKING NORTH

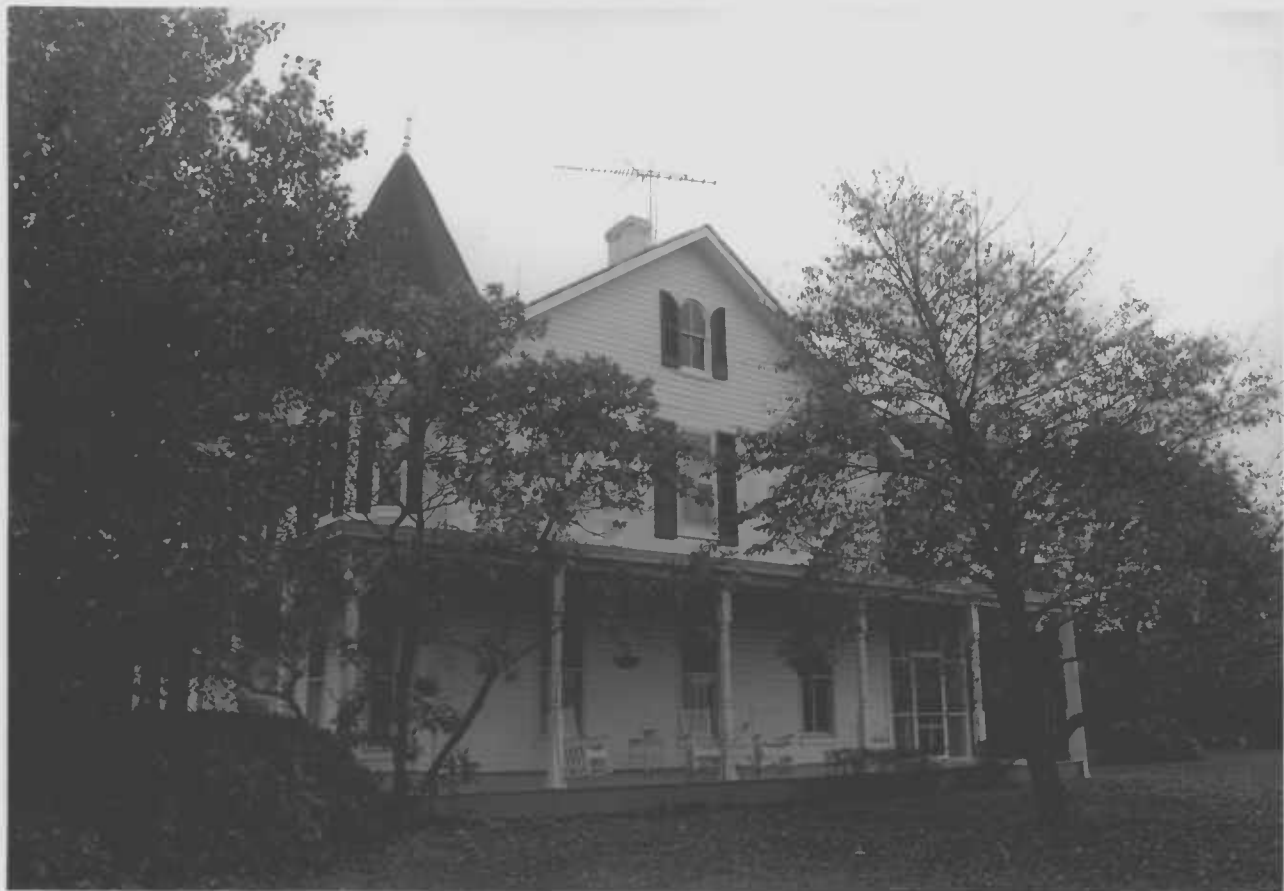
The east elevation main block includes an arched 4-light shuttered window in the attic story above a centered original 2/2 light window on the second floor. On the first floor, the porch has been enclosed to create a sunroom. Currently the enclosed porch wall includes a row of seven Craftsmen style 6/1 light windows.

CH - 213
BRINKWOOD
CHARLES Co. MD
11/2000
C. CURRY
MD SHPD
EAST ELEVATION
2 OF 18

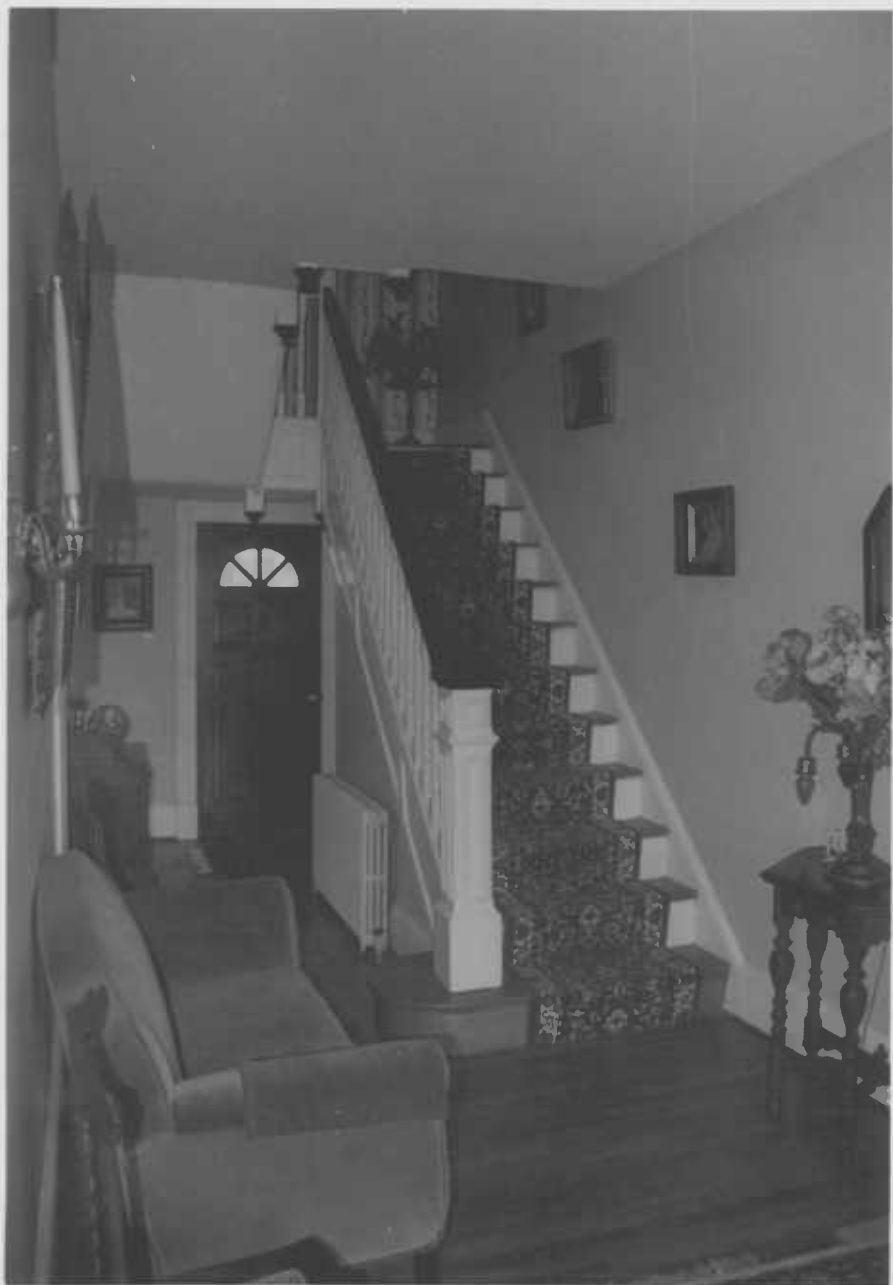
MD SHPO
CENTER HALL 6 OF 18

The interior floorplan follows a traditional center passage double pile plan with two rooms flanking either side of the center hall. The formal parlor is situated in the northwest corner of the dwelling followed by the study to the rear. Across the hall is the second parlor, which is slightly less ornate, in front of the dining room. Some of the original exterior wall has been removed in the second parlor to provide access to the 1930's -40's sunroom. The porch/sunroom extends into a hallway located in the kitchen wing where there are found several pantries and closets. To the rear of the kitchen wing is the modern kitchen.

The main stair is found on the west side of the hall. The second floor includes several bedrooms and a small room above the entranceway which was once a second story porch, but has been converted into a bath. The second story kitchen wing includes a nursery with a separate unadorned narrow staircase. This staircase was originally accessible from the first floor hall in the kitchen wing and by an outside doorway, now covered, on the east wall.

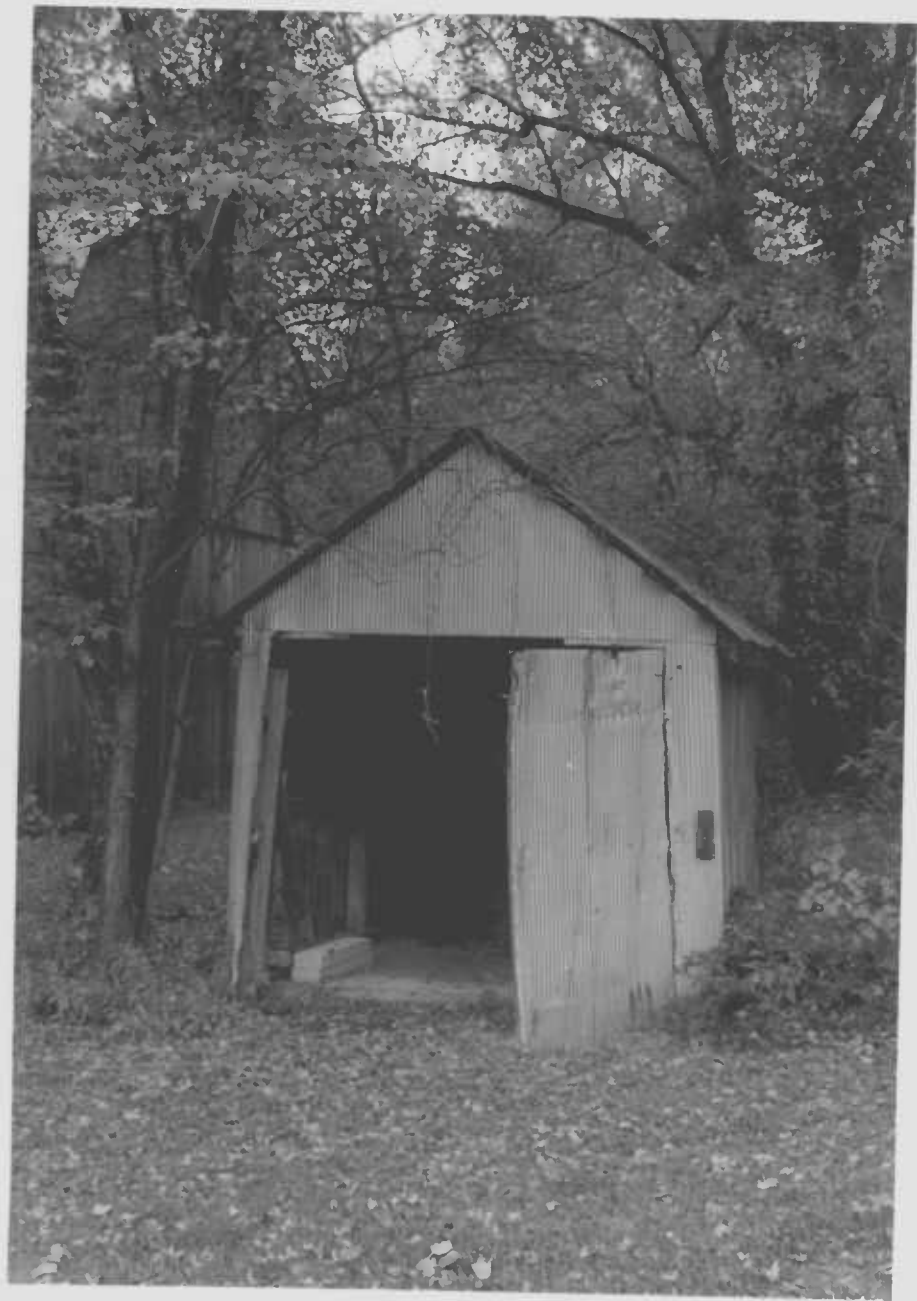
11 OF 18

Across the lane is what is referred to by the owners as a grinding house, which was used in the mid-twentieth century to grind grain. In the center stood a heavy piece of belt driven grinding machinery. The belt was extended into the lane when in use. This structure, while currently clad in metal sheeting contains a heavy timber frame, indicating an earlier construction date than the exterior might otherwise suggest. Currently it has a poured concrete floor.

GRINDING HOUSE, LOOKING SOUTH

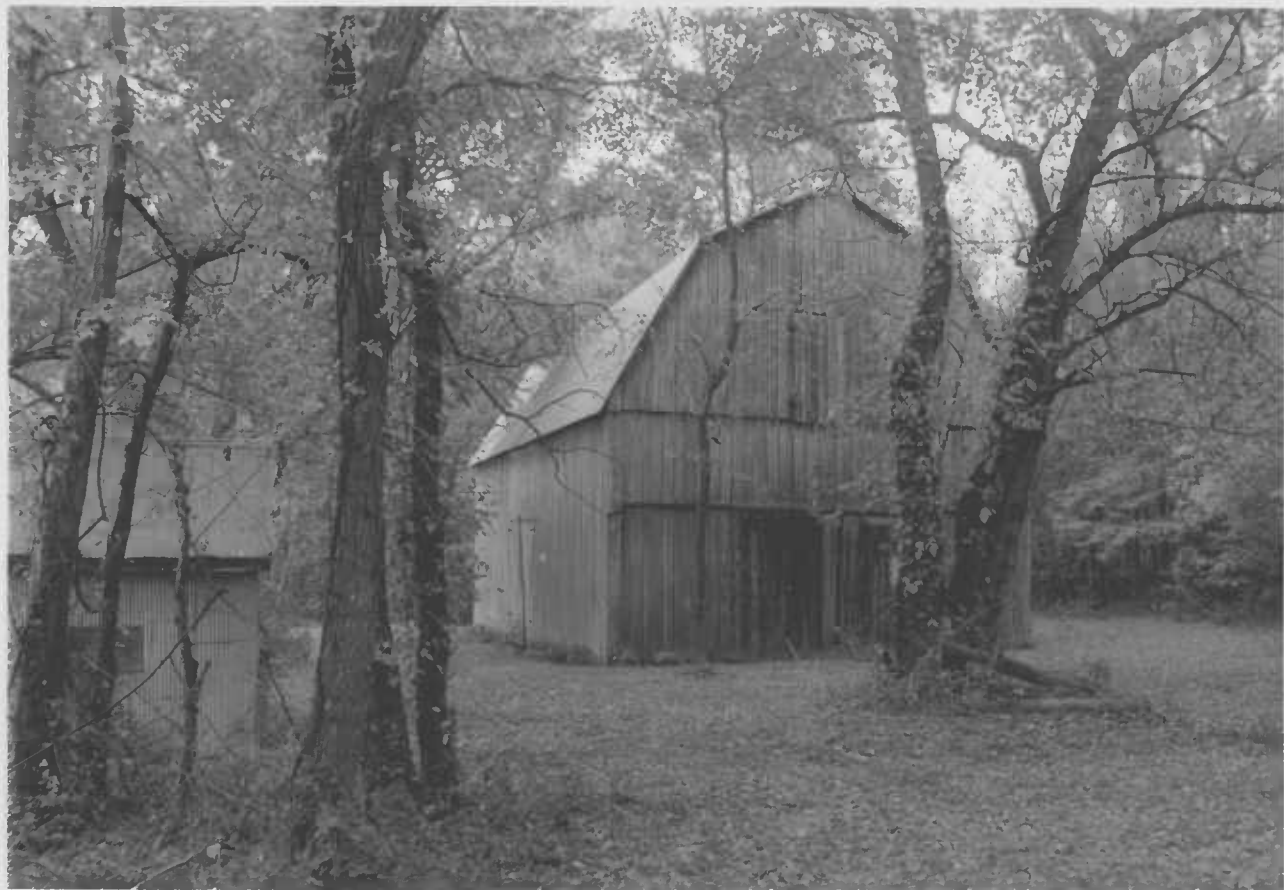
13 OF 18

Behind the lane is a large gambrel roof tobacco barn probably constructed during the 1940's. It has a continuous concrete block foundation with block piers supporting interior posts.

TOBACCO BARN, LOOKING SE

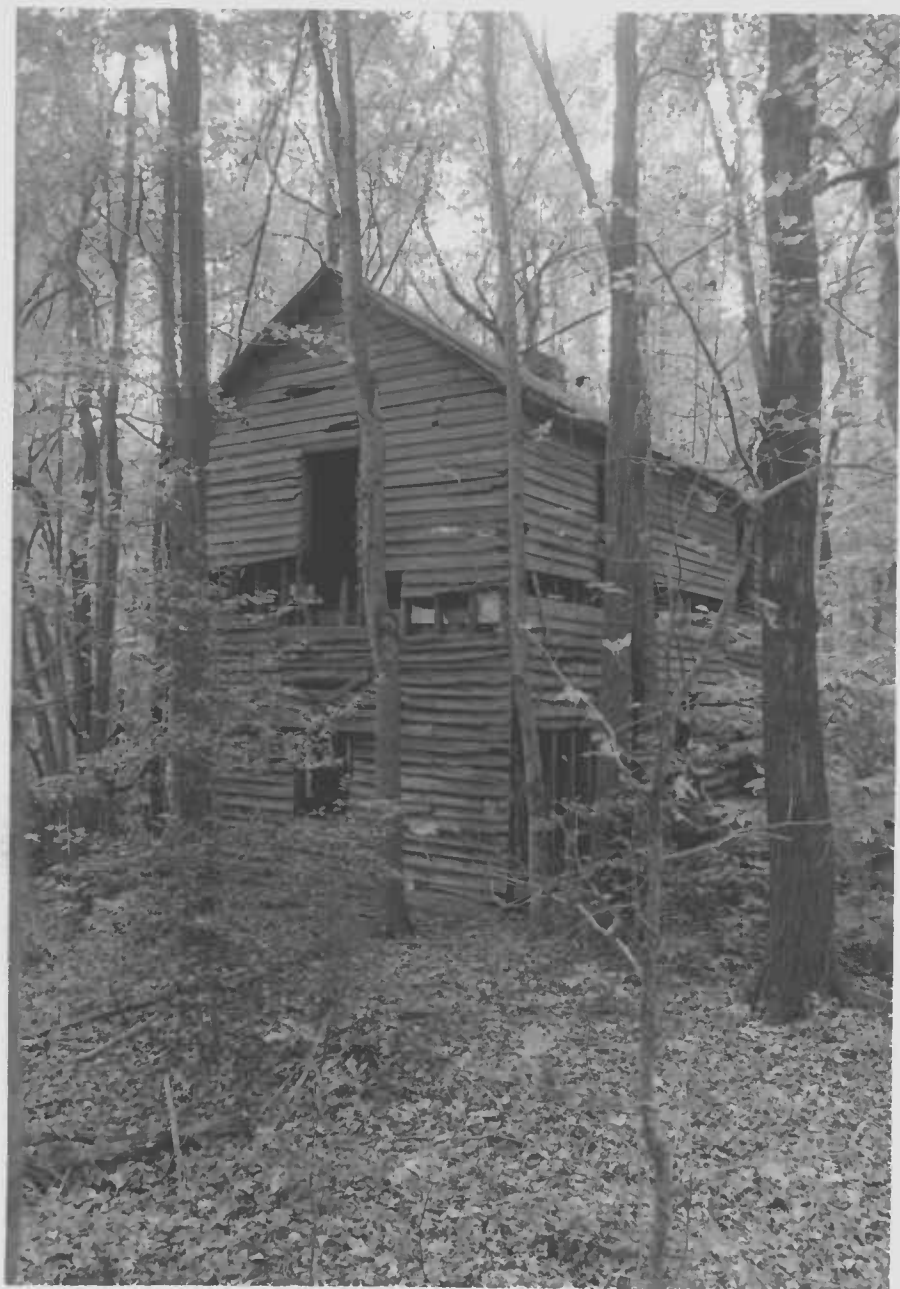
14 OF 18

A two story, four room, single pile frame tenant house stands in a now wooded area to the west of the main house. The simple building is covered in weatherboard siding and has a metal roof. A single chimney pierces the center of the roof. The main door is centrally placed and enters onto the largest room in the house. To the west is a smaller room, probably the kitchen that contains a rear door on the south wall and a corner stair in the northwest corner. The frame is exposed in sections and reveals a combination of lighter studs and heavier corner posts and downbraces. The building was later used to house tobacco as evidenced by the presence of rough poles hung just below the ceiling.

According to the owners, this was occupied by the Jenifer family. Windows and doors are missing but the door frame contains remnants of early blue paint. This building is currently owned by the Bonifant family and is associated with tax map 35, parcel 105.

TENANT HOUSE, LOOKING SW

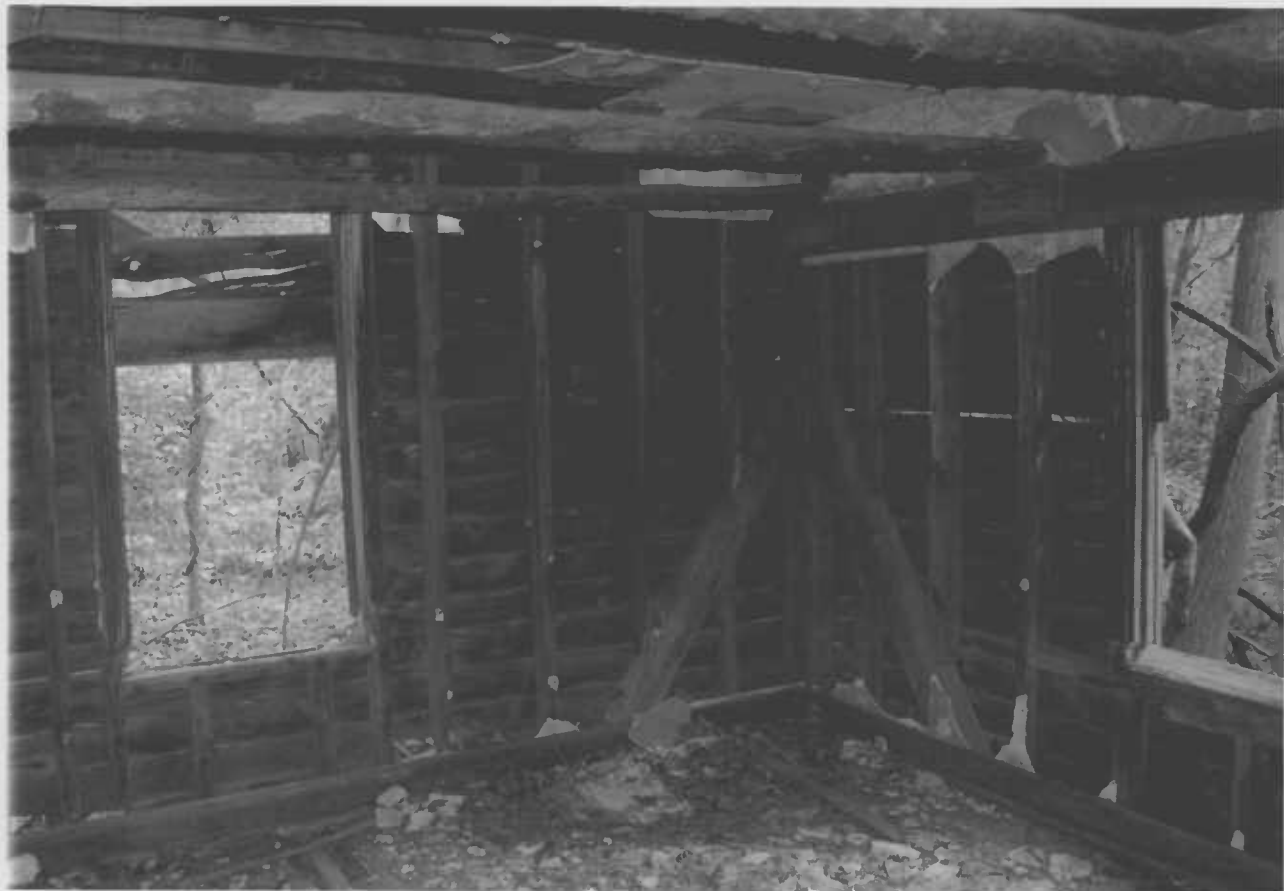
16 of 18

TENANT HOUSE INTERIOR, SE CORNER 1st FLOOR
